## **VISUAL INSPECTION OF SPENT FUEL ELEMENTS FROM ININ TRIGA MARK III RESEARCH REACTOR**

## **4. RESULTS**

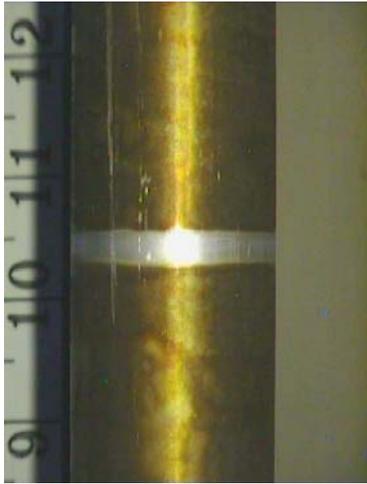
**Figure 4 – FE # 7126**

<b>Fuel ID Number</b>	<b>Fuel Design</b>	<b>Location</b>	<b>Inspection Results -Observations</b>
883A (Fresh Fuel)	FLIP	Outside of pool	Fresh fuel placed underwater in holder for visual examination. 4x magnification shows minor surface bumps and scratches.
5079	Low-enriched fuel	Storage Rack	Dark orange-brown-blue region 38 mm in length. Scratches both circumferential and longitudinal. Debris both along lines and as separate particles were attached to cladding. The gas-fill port seal was observed on the lower end fitting.
5113	Low-enriched fuel	Storage Rack	Same general observations as for fuel ID 5079. In addition, a semi-shiny band about 3,1 mm wide and irregular was observed in the colored region. The band had several white deposits adjacent to it.
5056	Low-enriched fuel	Storage Rack	Same as for fuel ID 5079.
7126	Low-enriched fuel	Reactor Core	Same general features as for fuel ID 5079. In addition, a clear, sharp shiny-metal band approximately 6,3 mm wide and corresponding to 22,8 mm from the bottom of the fuel cylinder was observed within the colored region, showed in the fig. 4. Thin bands of dark and light colors within the colored region were observed. Debris and scratches were observed and appeared to be less in amount than element ID 5079.

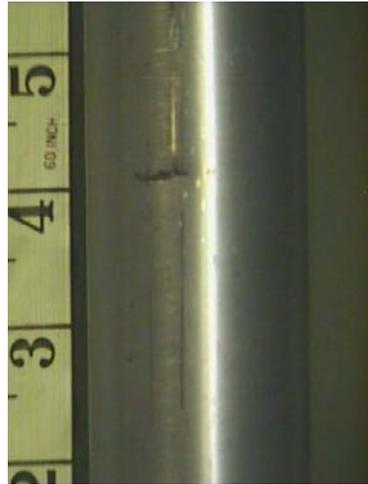
**Figure 5 – FE # 7130**

7130	Low-enriched fuel	Reactor core	Same as fuel ID 7126, including the shiny-metal band. Not the same irregular clear region. A small black stain approximately 6,3 mm long was observed. A still photography of this fuel is showed in the Fig. 5.
8841		Reactor core	Same as fuel ID 7126 but with two shiny-metal bands, each approximately 6,3 mm wide. A still photography of this fuel is showed in the Fig. 6.
5107		Reactor core	Same as fuel ID 7126 but no shiny-metal bands. The bottom and top boundaries between the colored regions were not as distinct as the other element examined. Still photographs of this fuel are showed in the Fig. 7 to 9.
